**COAL ASH IMPOUNDMENT
SITE ASSESSMENT DRAFT REPORT**

**6th Street Power Generating Station
Alliant Energy
Cedar Rapids, Iowa**

KLEINFELDER PROJECT NUMBER 118953-4

May 2, 2012

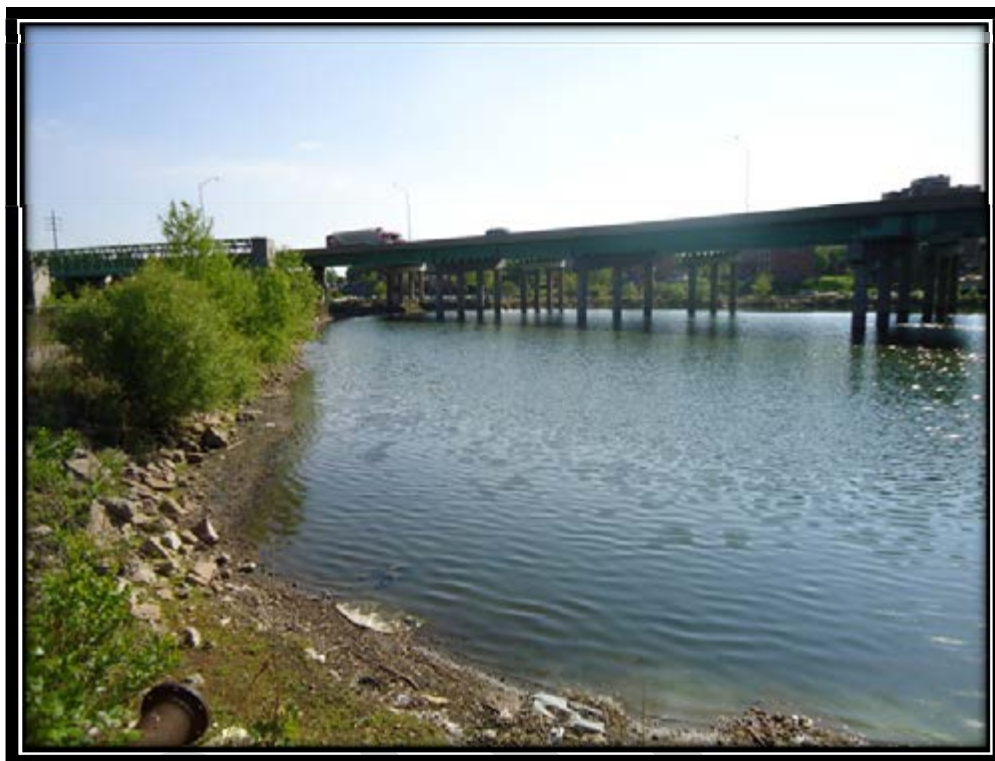
Overall, the upstream slope of the impoundment was in fair condition. Photos 9, 10, 13, 17, and 21 at the end of this section show the conditions of the upstream slope. Specific observations include:

Photo 9 – General Conditions Photograph Ash Pond 3
May 24, 2011 NPDES# IOWA-5715109

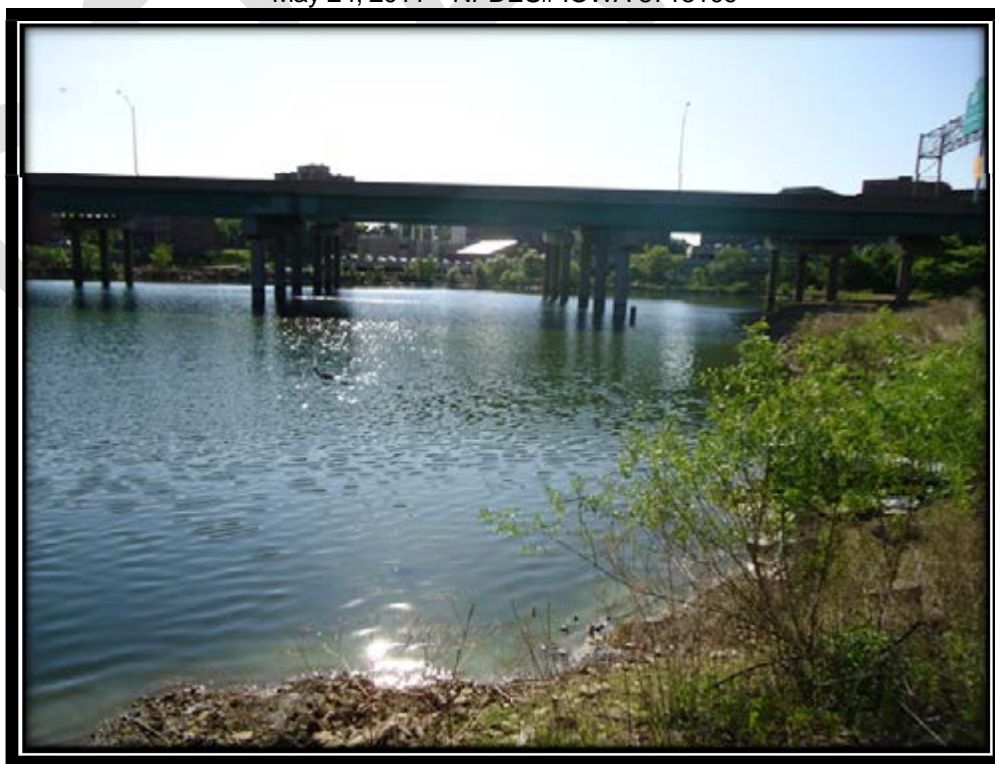
Inflow into Ash Pond 3 is via the discharge conduit from Ash Pond 2 as well as rainfall runoff that flows naturally into the impoundment and stormwater runoff that is transferred from the I-380 downspouts into the pond. The inlet pipe can be seen in photo 10 at the end of this section. In addition, downspouts from I-380 can be seen in photo 15 at the end of this section. The inlet pipe from Ash Pond 2 appeared to be in fair condition, while the downspouts appeared to be in satisfactory condition.

Photo 10 – General Conditions Photograph Ash Pond 3
May 24, 2011 NPDES# IOWA-5715109

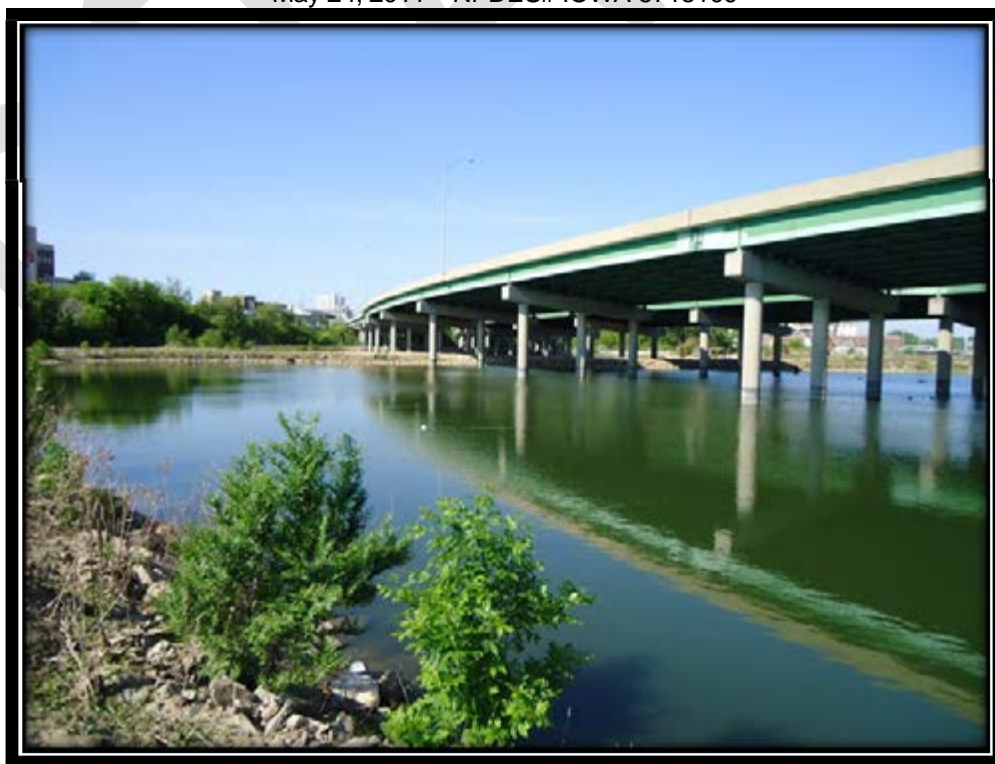
Photo 18 – General Conditions Photograph Ash Pond 3
May 24, 2011 NPDES# IOWA-5715109

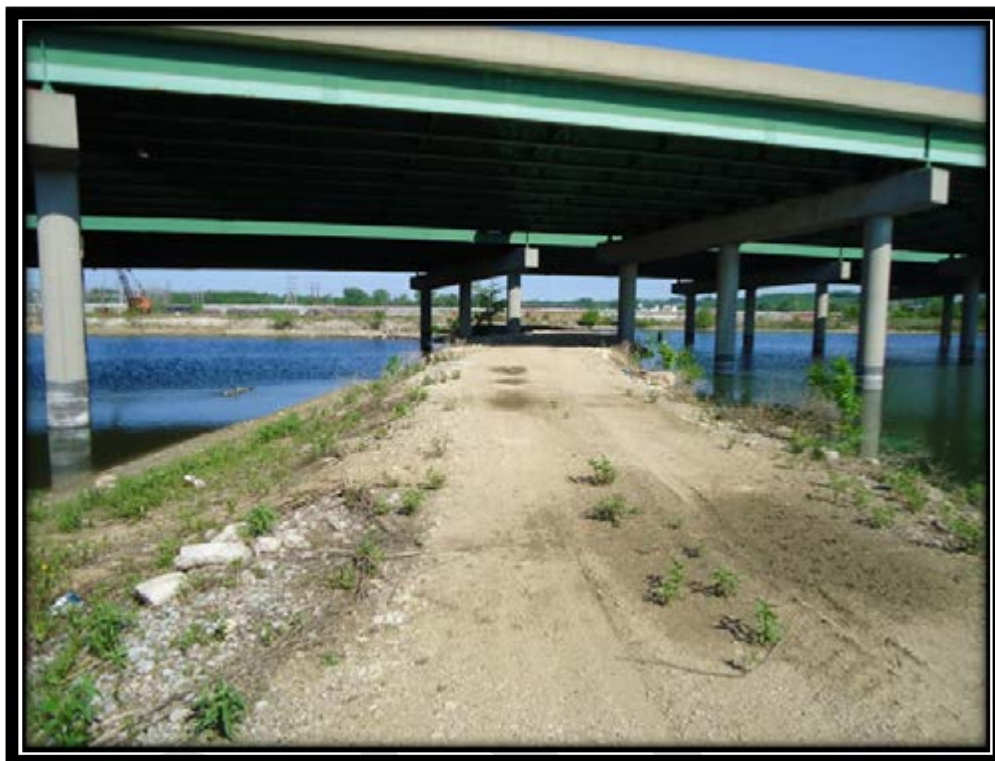
Overall, the upstream slope of the impoundment was in fair condition. Photos 23, 24, and 28 at the end of this section show the conditions of the upstream slope. Specific observations include:

Photo 23 – Embankment between Ash Ponds 3 and 4
May 24, 2011 NPDES# IOWA-5715109

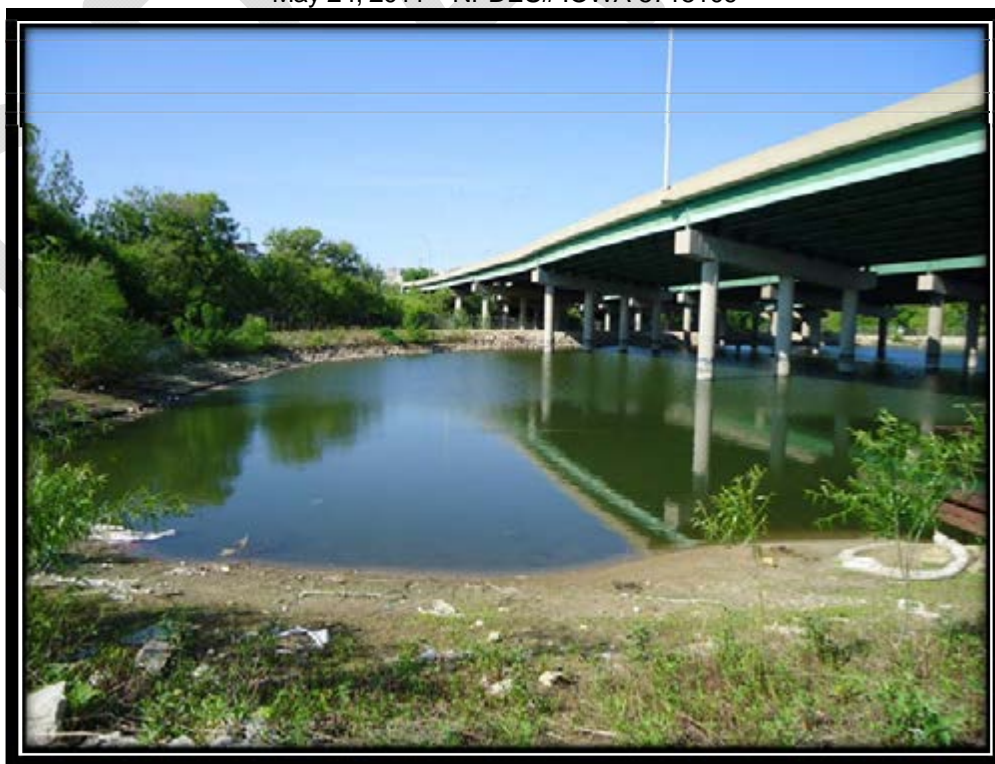
Photo 24 – General Conditions Photograph Ash Pond 4
May 24, 2011 NPDES# IOWA-5715109

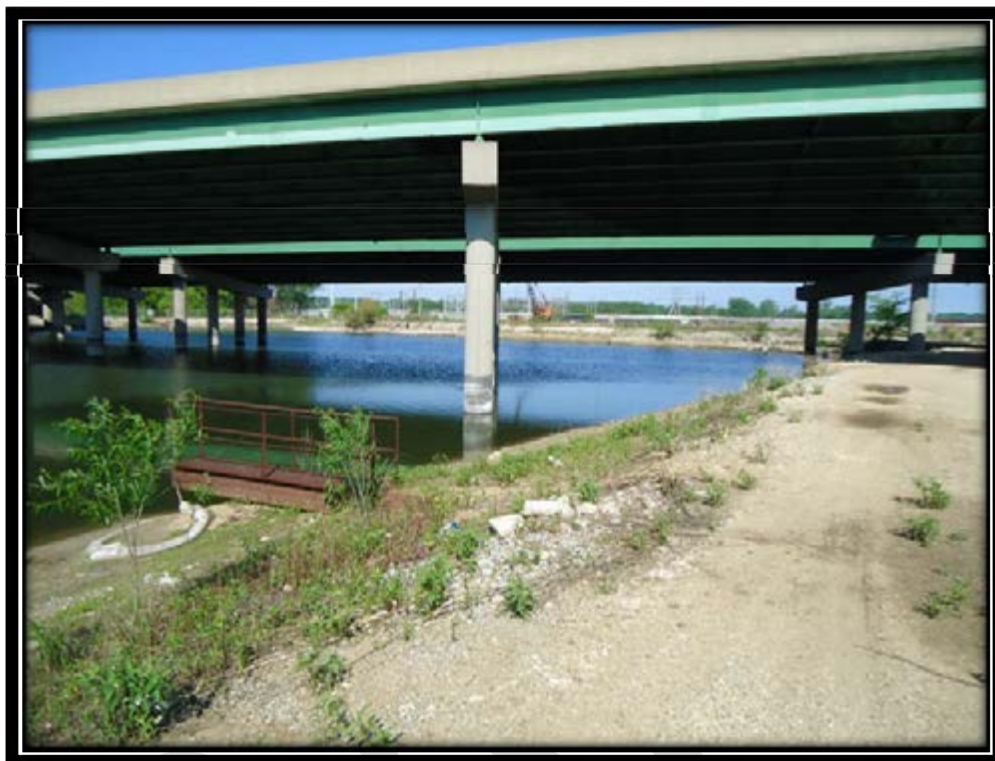
Overall, the crest of the impoundment was in fair condition. Photos 25, 28 and 30 show the condition of the crest. Specific observations include:

Photo 25 – General Conditions Photograph Ash Pond 4
May 24, 2011 NPDES# IOWA-5715109

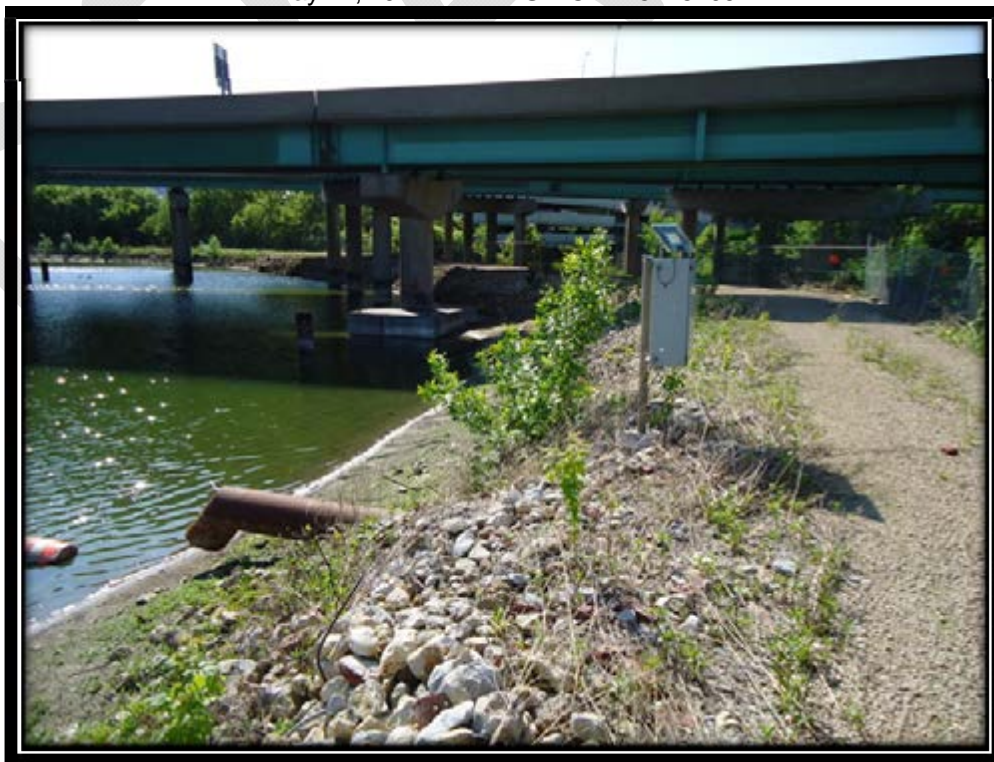
Photo 28 – Ash Pond 4 Outlet Pipe
May 24, 2011 NPDES# IOWA-5715109

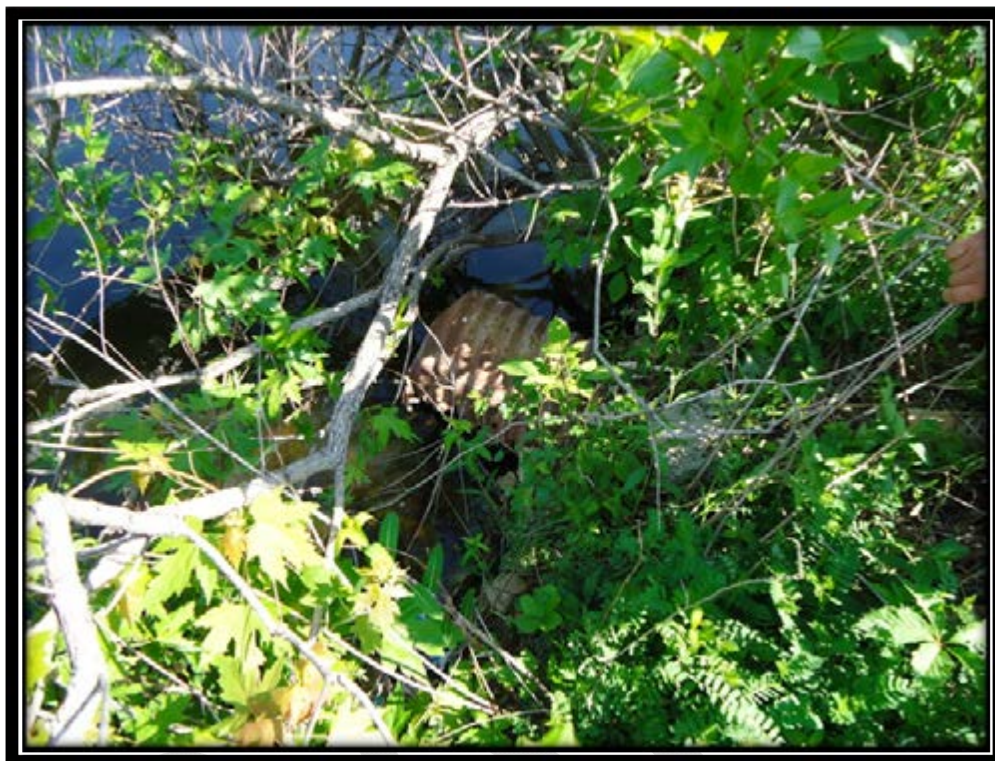
Photo 35 – Corrugated Metal Pipe Outlet from Ash Ponds to Cedar Lake
May 24, 2011 NPDES# IOWA-5715109
